## CommScope Smooth-Wall Transmission Line System Survives Extreme Testing Without Secondary Waterproofing

### New Smooth-Wall Technology Makes A Big Impression

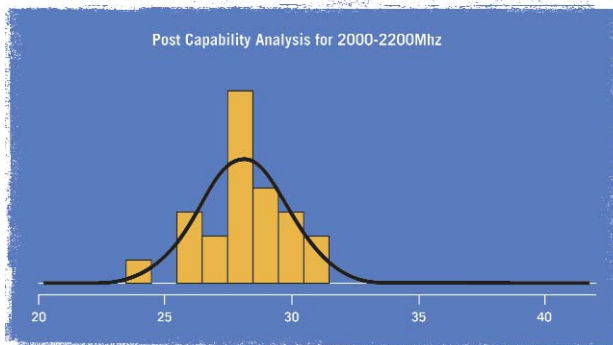
Diagram 1 Side-by-side comparison of pre-and-post test analysis

Once connected, the assemblies were allowed to return to room temperature. After the temperature had stabilized at 20°C (68°F), each assembly was tested for Return Loss and DTF (Distance to Fault). (See diagram 1)

At the completion of the final cycle of environmental tests, each assembly was tested once again for Return Loss and DTF (Distance to Fault).

(See Diagram 1)

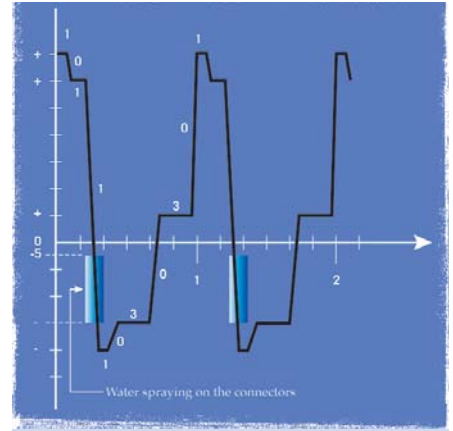
Diagram 2 Thermocycling profile

After benchmarking, the 24 samples were returned to the thermal chamber and subjected to prolonged extreme thermal cycling (See diagram 2). Each cycle ranged from -40°C (-40°F) to 60°C (140°F) and lasted approximately 12 hours. During the cycle, the temperature was held at the highest and lowest point for sixty minutes.

As the temperature passed from -5°C (23°F) to -40°C (-40°F) during each cooling cycle technicians entered the chamber to spray a cold water mist directly onto the cable-connector assembly. Numerous cold-water mist applications were made during each cycle

in an attempt to build up an ice coating of at least 1/16 inch (1.6mm) thick. The ice layer remained for three hours as the temperature rose slightly to -30°C (-22°F). After three hours, the temperature began to rise past the

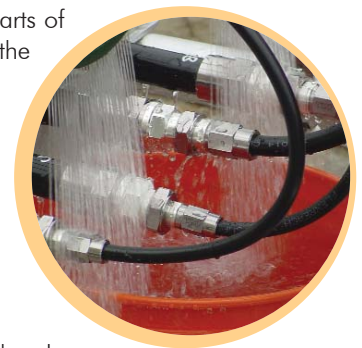
The test team conducted pre-test benchmarking as before. The samples were then placed in the test chamber where multiple showerheads were situated a few inches away from the assemblies and aimed directly on the cable-connector junction. Water spray from the showerheads exposed the cable-connector assemblies to the equivalent of 27 inches of rain.

The samples were then immediately subjected to thermal cycling during which temperatures ranged from -20°C (-4°F) to 27°C (80.6°F). When the temperature dropped to the freezing point, the samples were sprayed with a cold-water mist to build an ice layer. As the ice melted, the water had the opportunity to migrate into any gaps between the cable-connector interface that may have developed. Each cycle lasted 6 hours. The test concluded at the end of 8 cycles; at which time, the assemblies underwent post-test electrical analysis.
